Case 297 : Narrative

Case Vehicle (A): 1999 Ford	Veh. (B): 1998 Chevrolet
Type: Escort ZX2, 2-door coupe	Type: Tracker, 4 x 4, 2-door convertible SUV
Driver: 49- year-old female	Driver: 49- year-old female
CDC: 12-FDEW-2	CDC: 02-RYEW-2

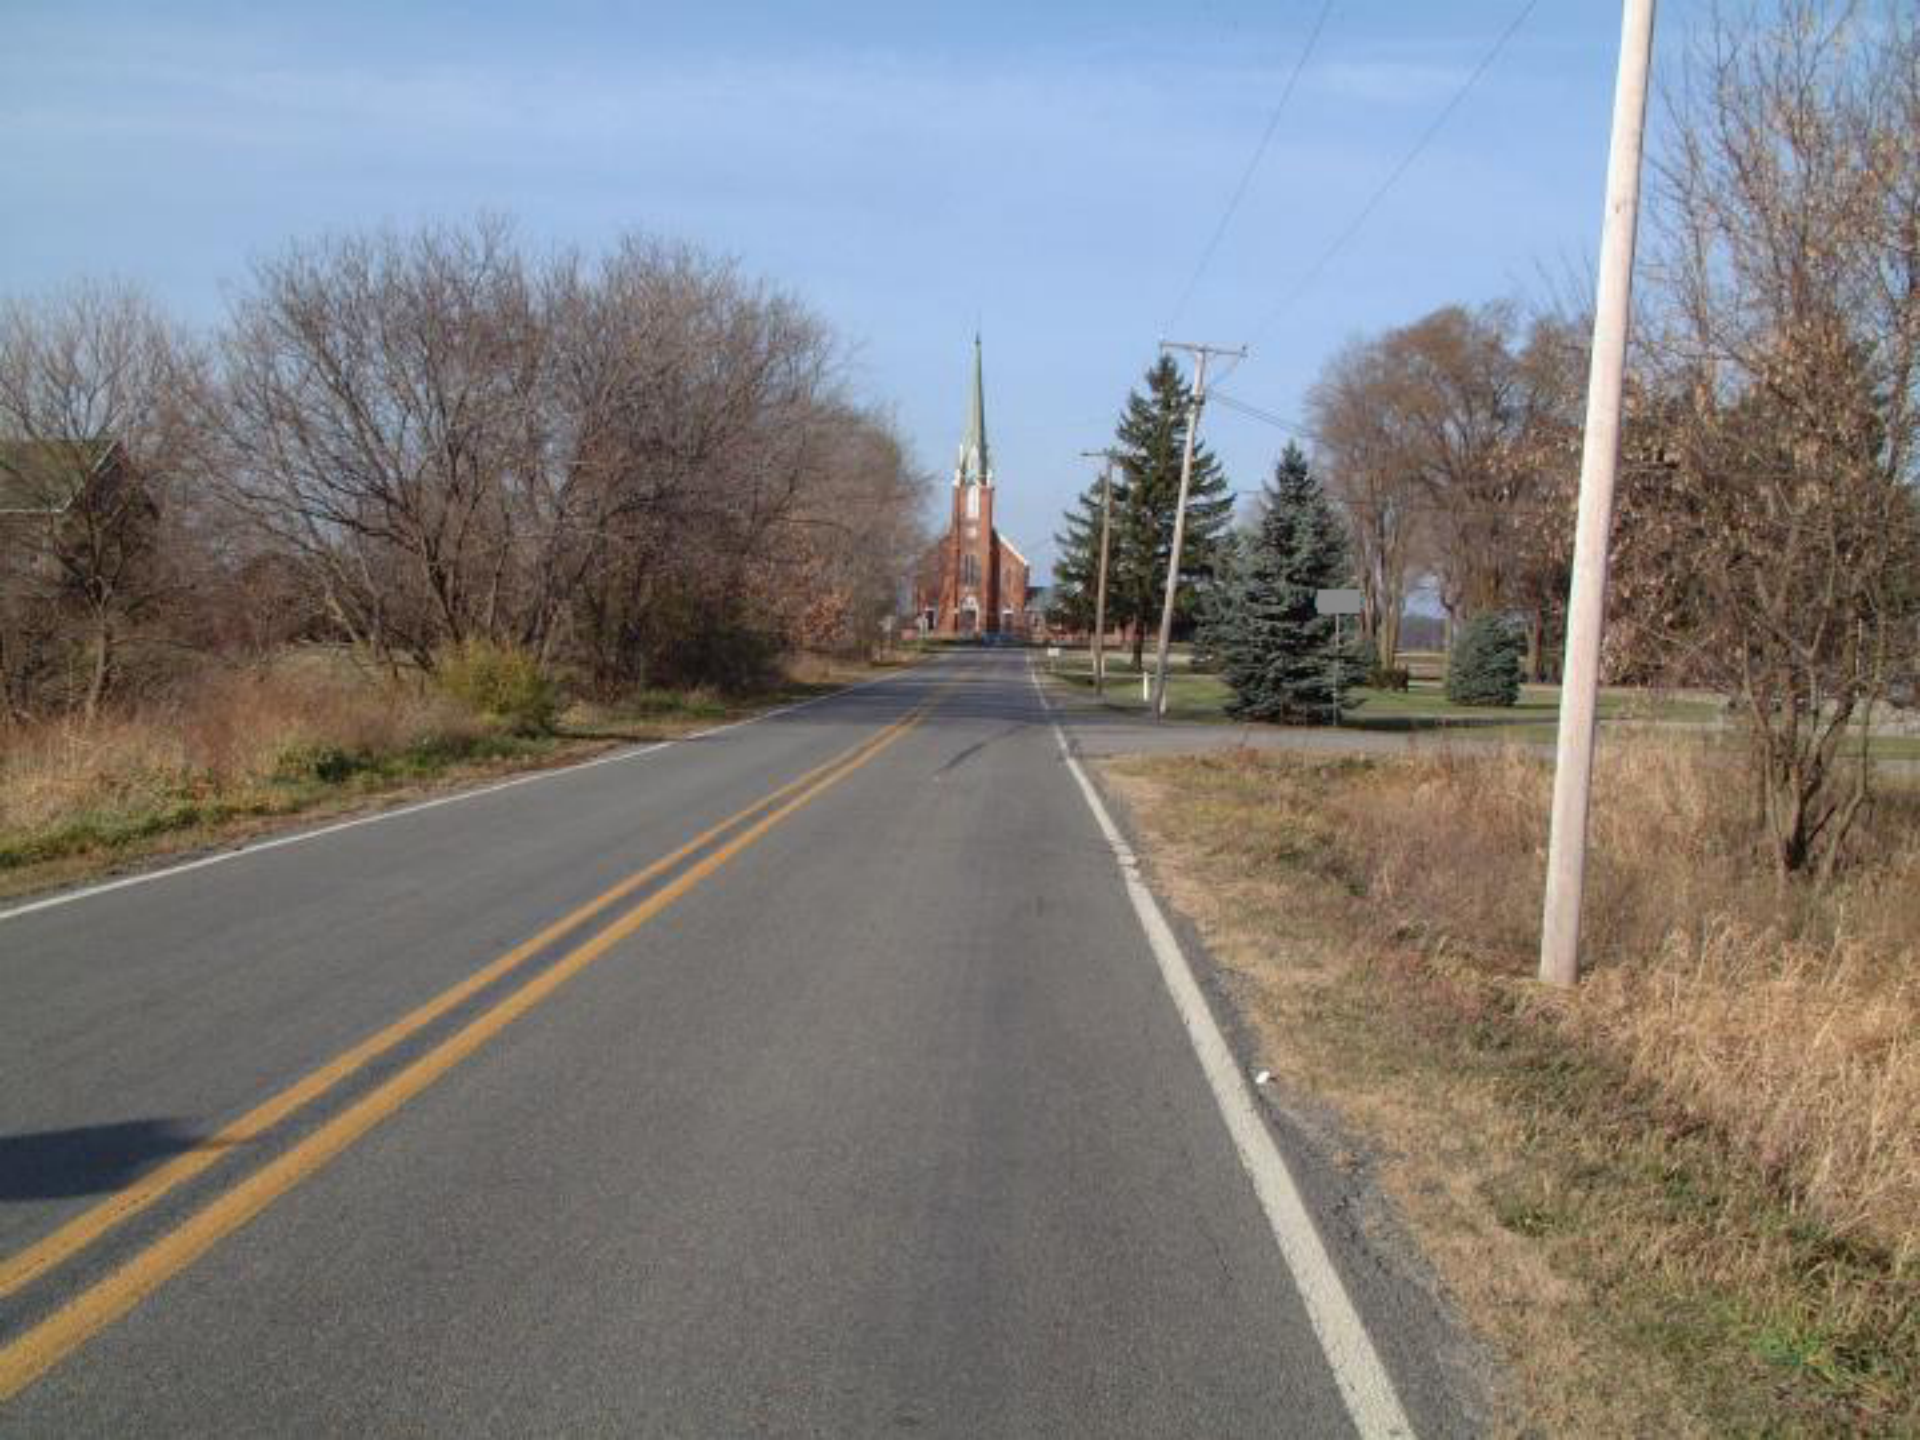
[5](#) Damage to case vehicle (A) was moderate. [6](#) Direct contact damage began at the right-front bumper corner and extended across the entire width of the front bumper. [7](#) The maximum crush was 28 cm to the right-front bumper corner.

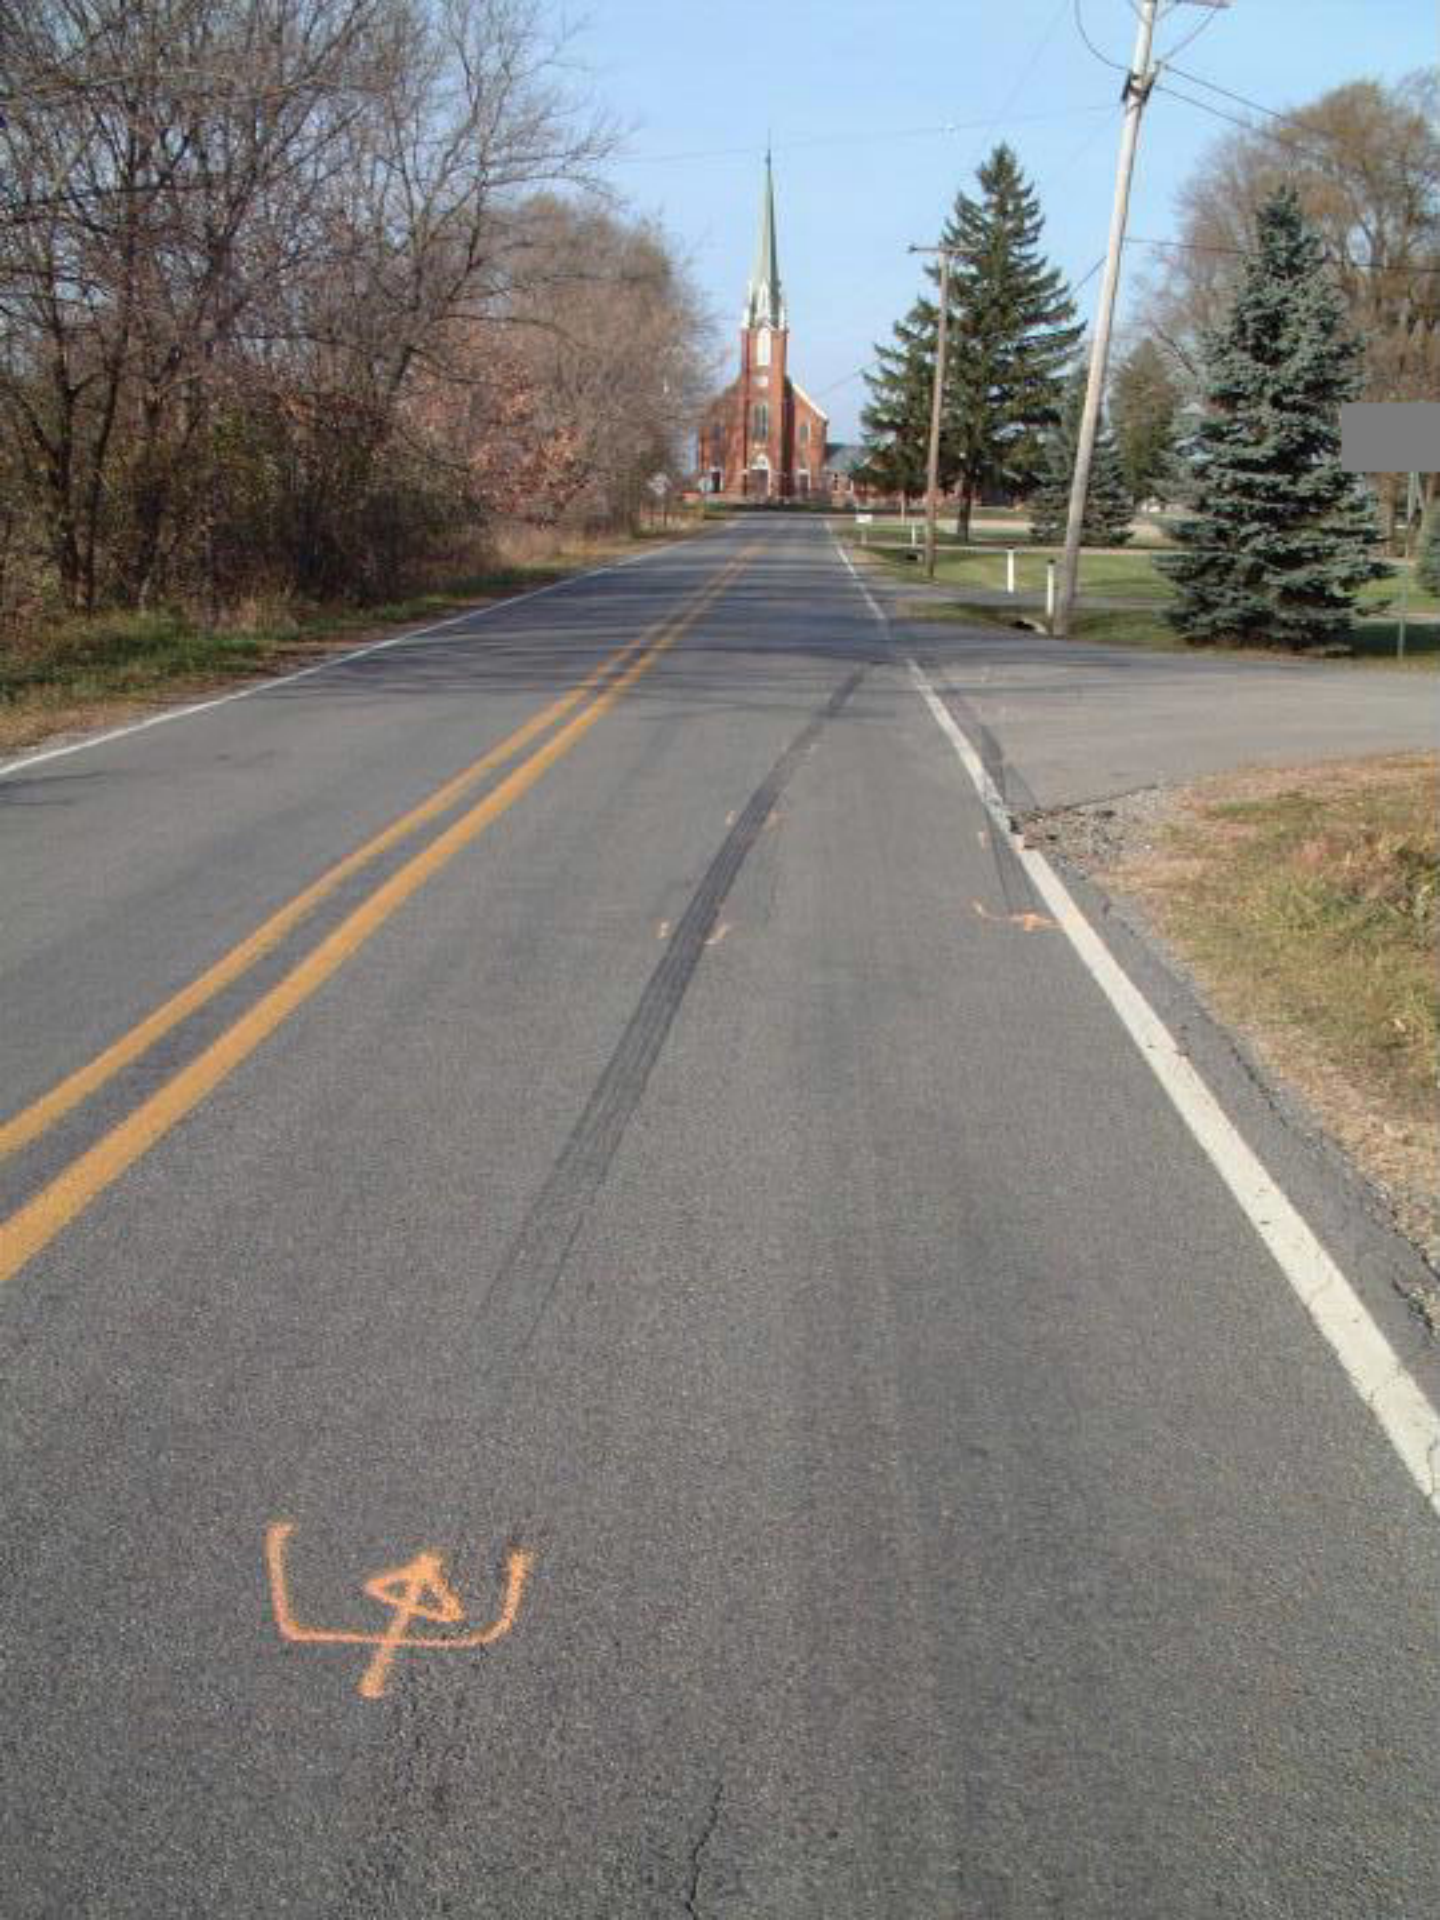
[8](#) Damage to vehicle (B) was moderate. Direct contact damage began just rear of the right B-pillar and extended 242-cm forward to the right-front bumper corner. The maximum crush was 17 cm to the right-front wheel well. [9](#) The front bumper was buckled and deflected to the left. [10](#) There was no damage to the rear of the vehicle. [11](#) The right wheelbase was reduced 9 cm, [12](#) there was no significant change to the left wheelbase. Using the WinSMASH crash-reconstruction program and [13](#) [14](#) [15](#) [16](#) c-values measured for case vehicle (A), and [17](#) [18](#) [19](#) vehicle (B), the following impact severities were calculated:

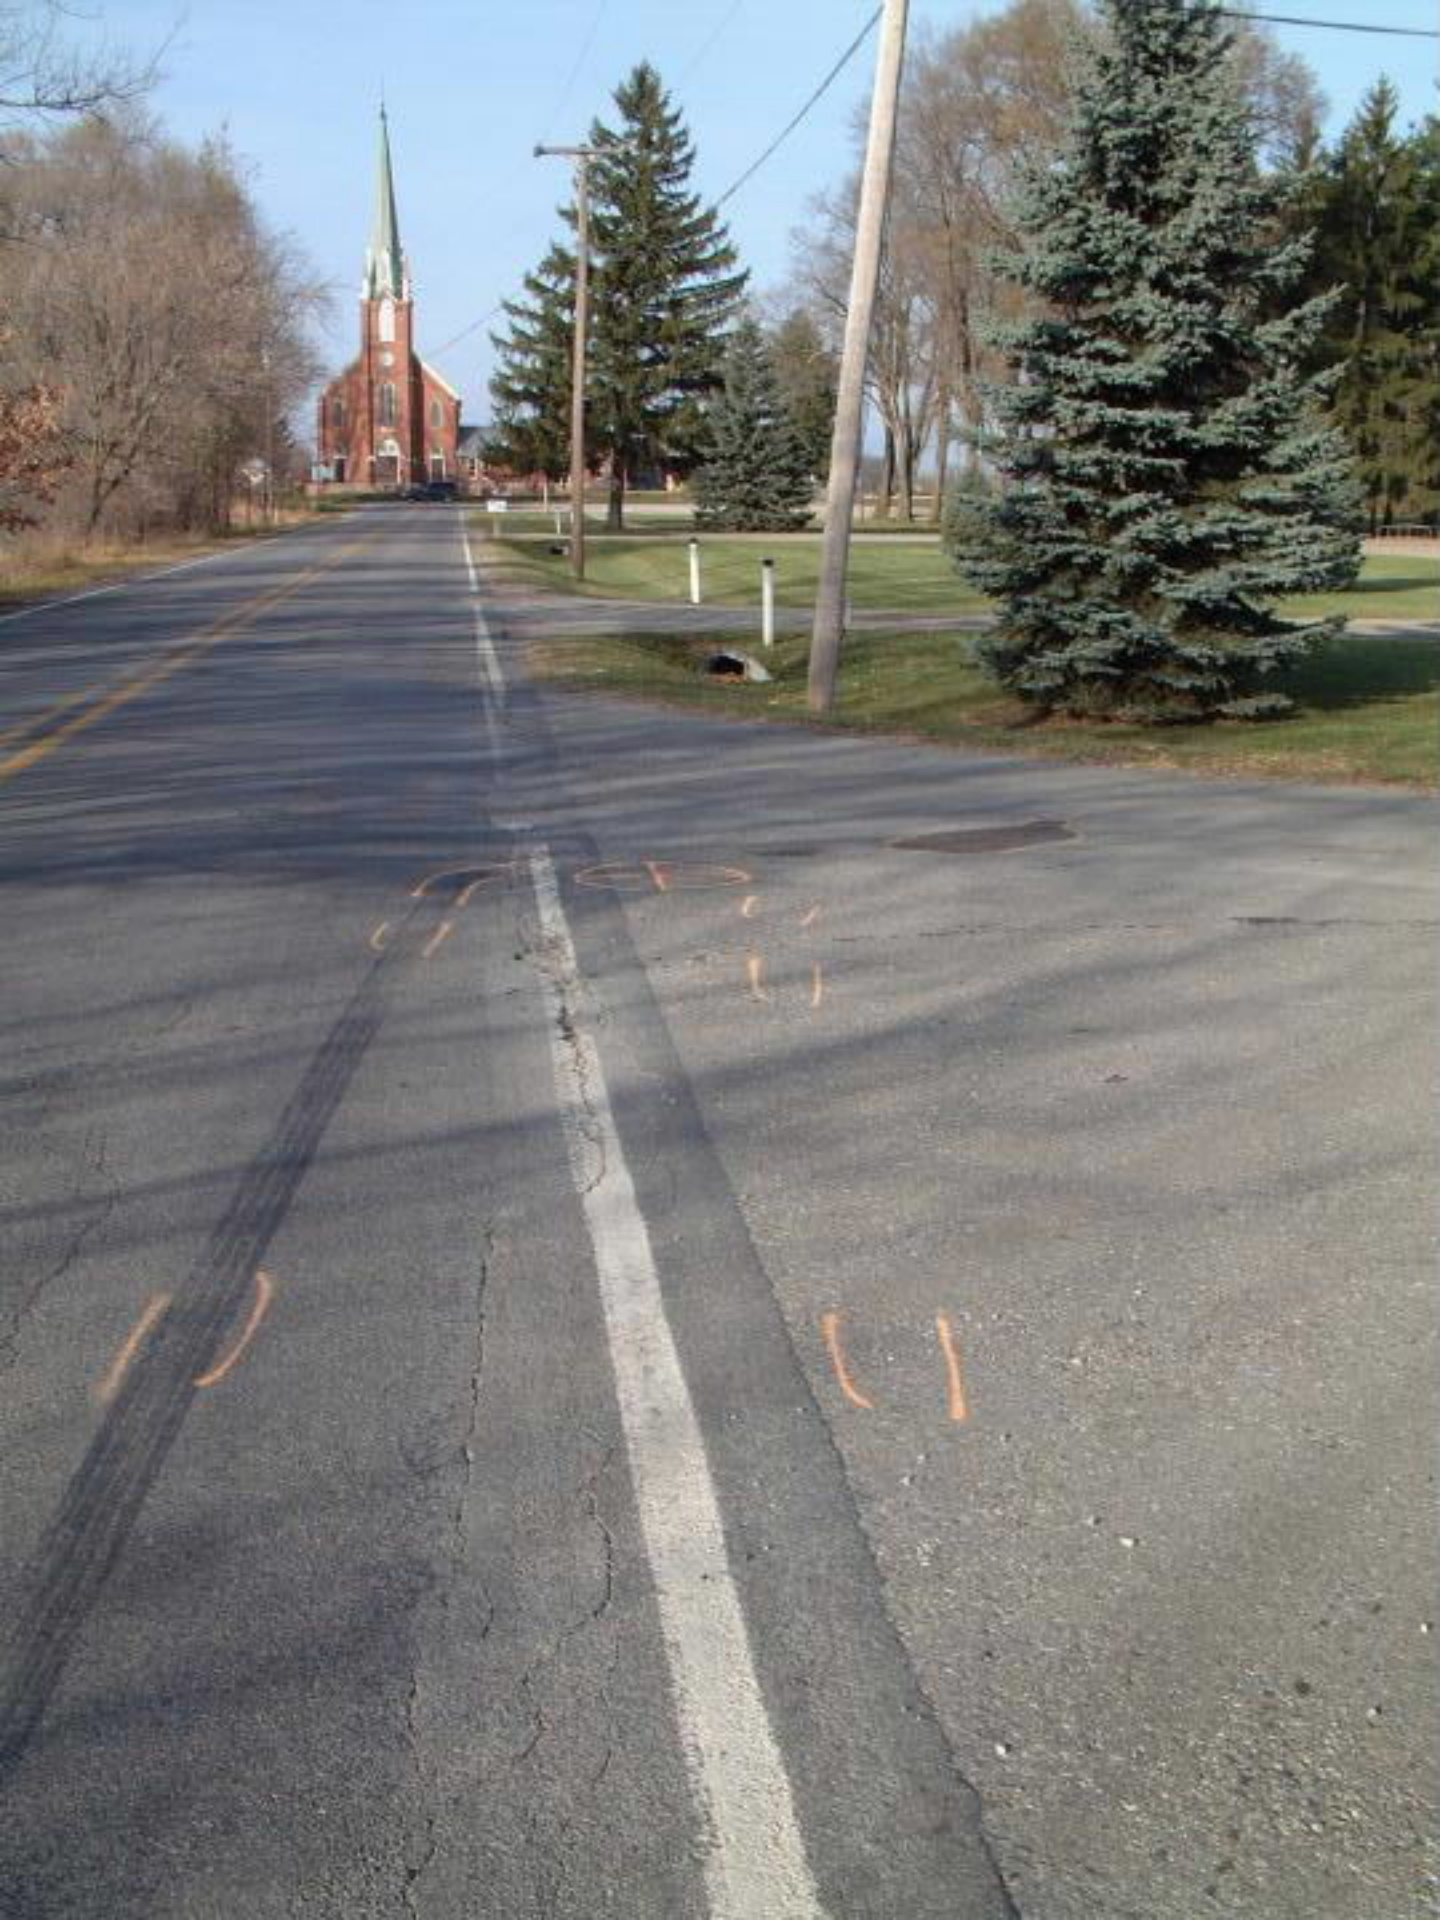
[20](#) Direct-contact damage was primarily to the front, but right of center, and included the bumper, the right fender, and the hood. The right portions of the bumper, the hood and the right fender were crushed rearward and the right fender was buckled. The grille and right headlight assembly were also damaged by direct contact. [21](#) The bumper cover was torn off, and [22](#) the right-front portion of the hood was buckled. [23](#) The hood latch was

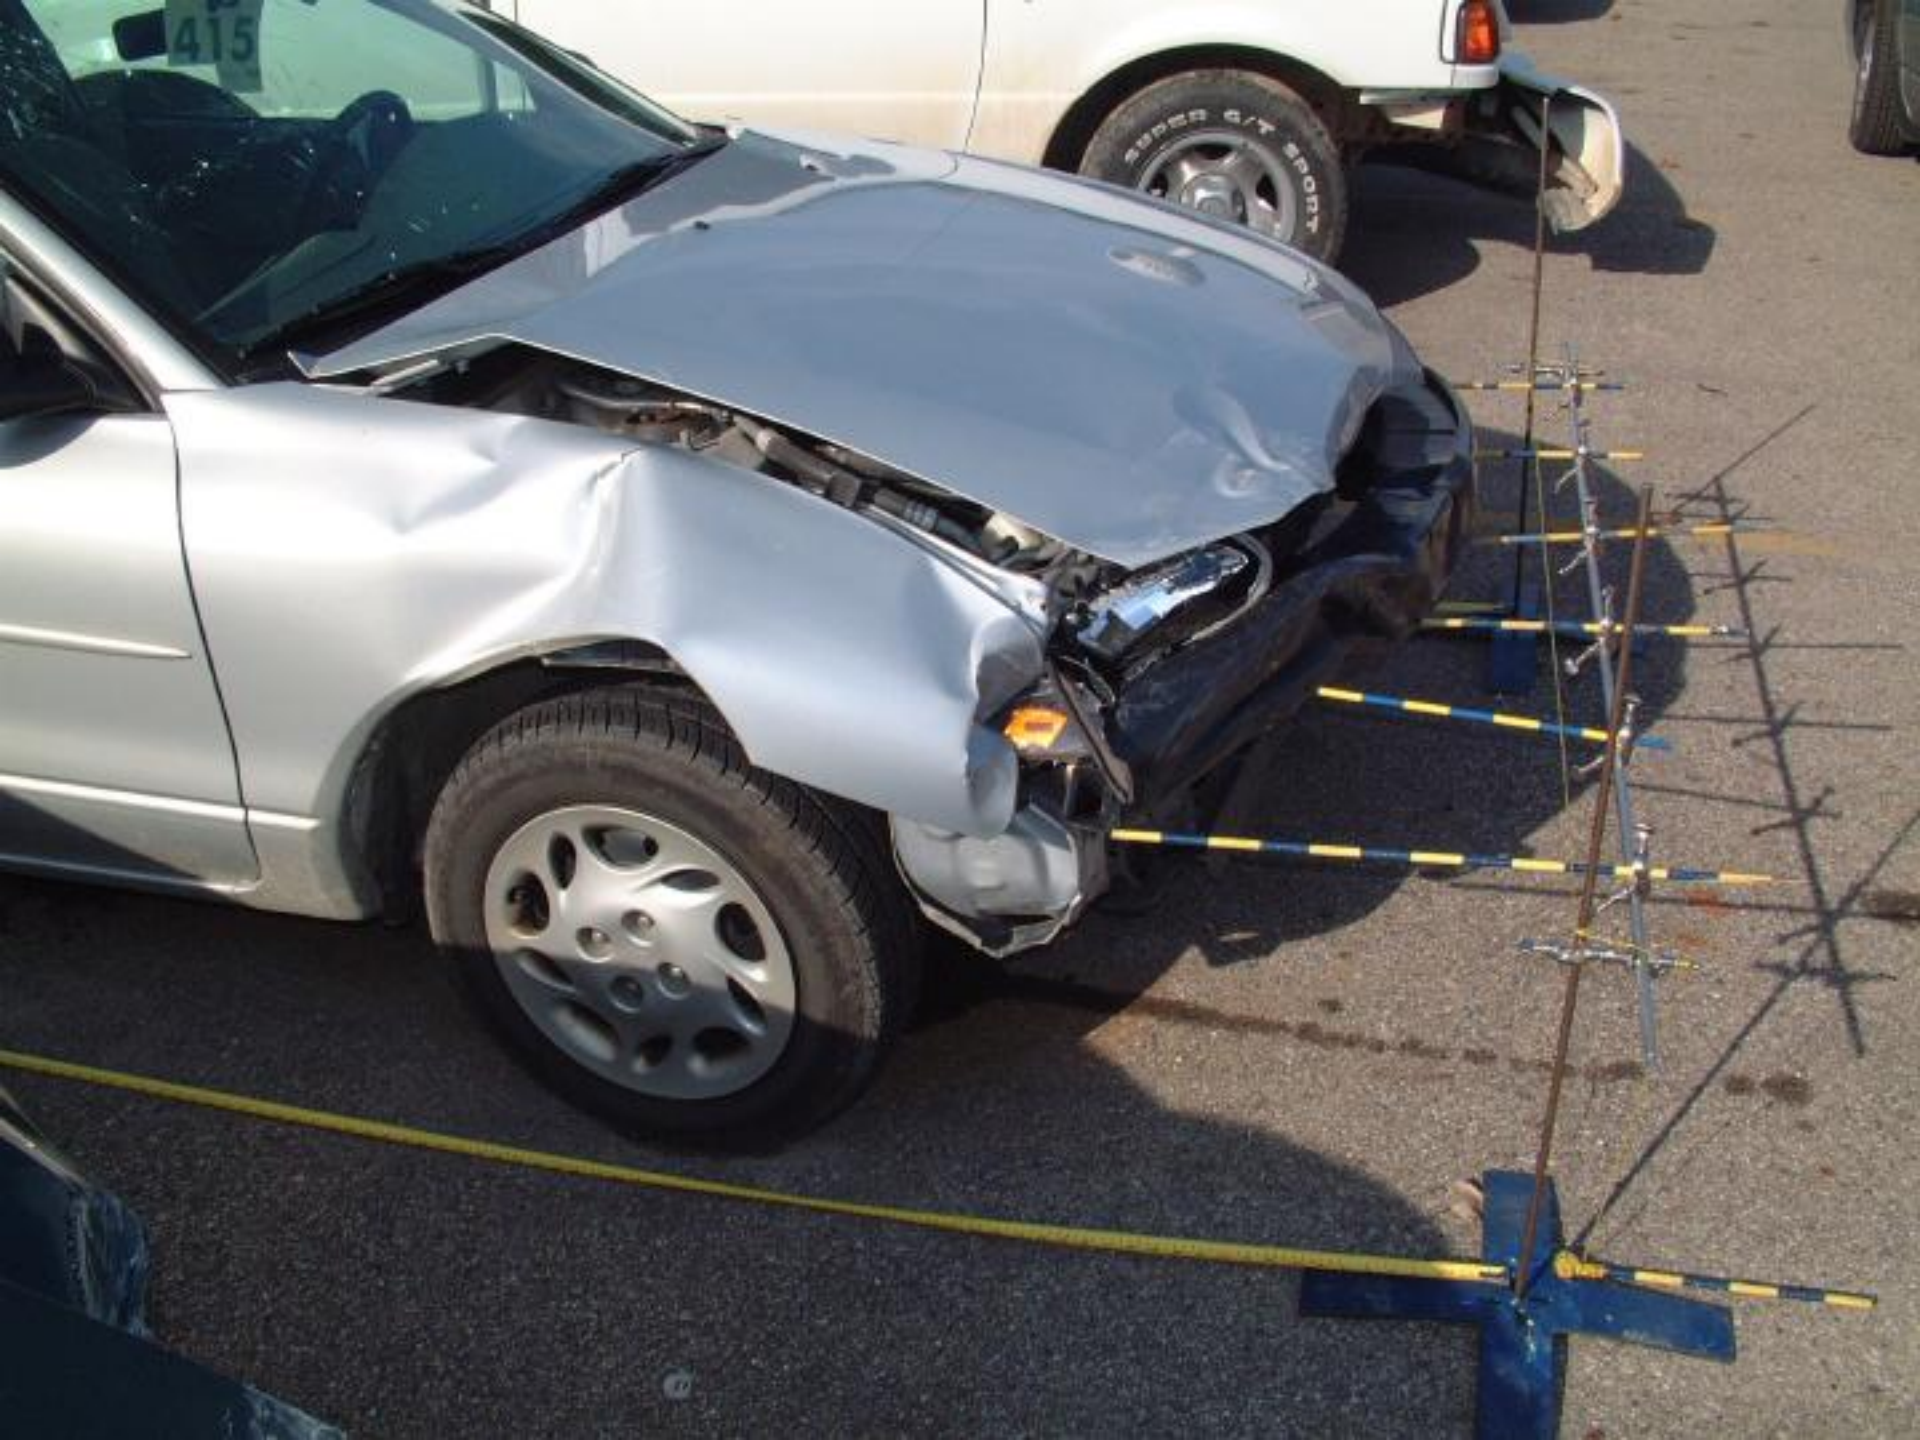
damaged, but it did not release and was not jammed closed, and there was no damage to the hood hinges. [24](#) The rear edge of the hood was slightly elevated but it did not contact the windshield, [25](#) which was cracked in a 31-cm long star pattern on the right half from passenger airbag cover contact.

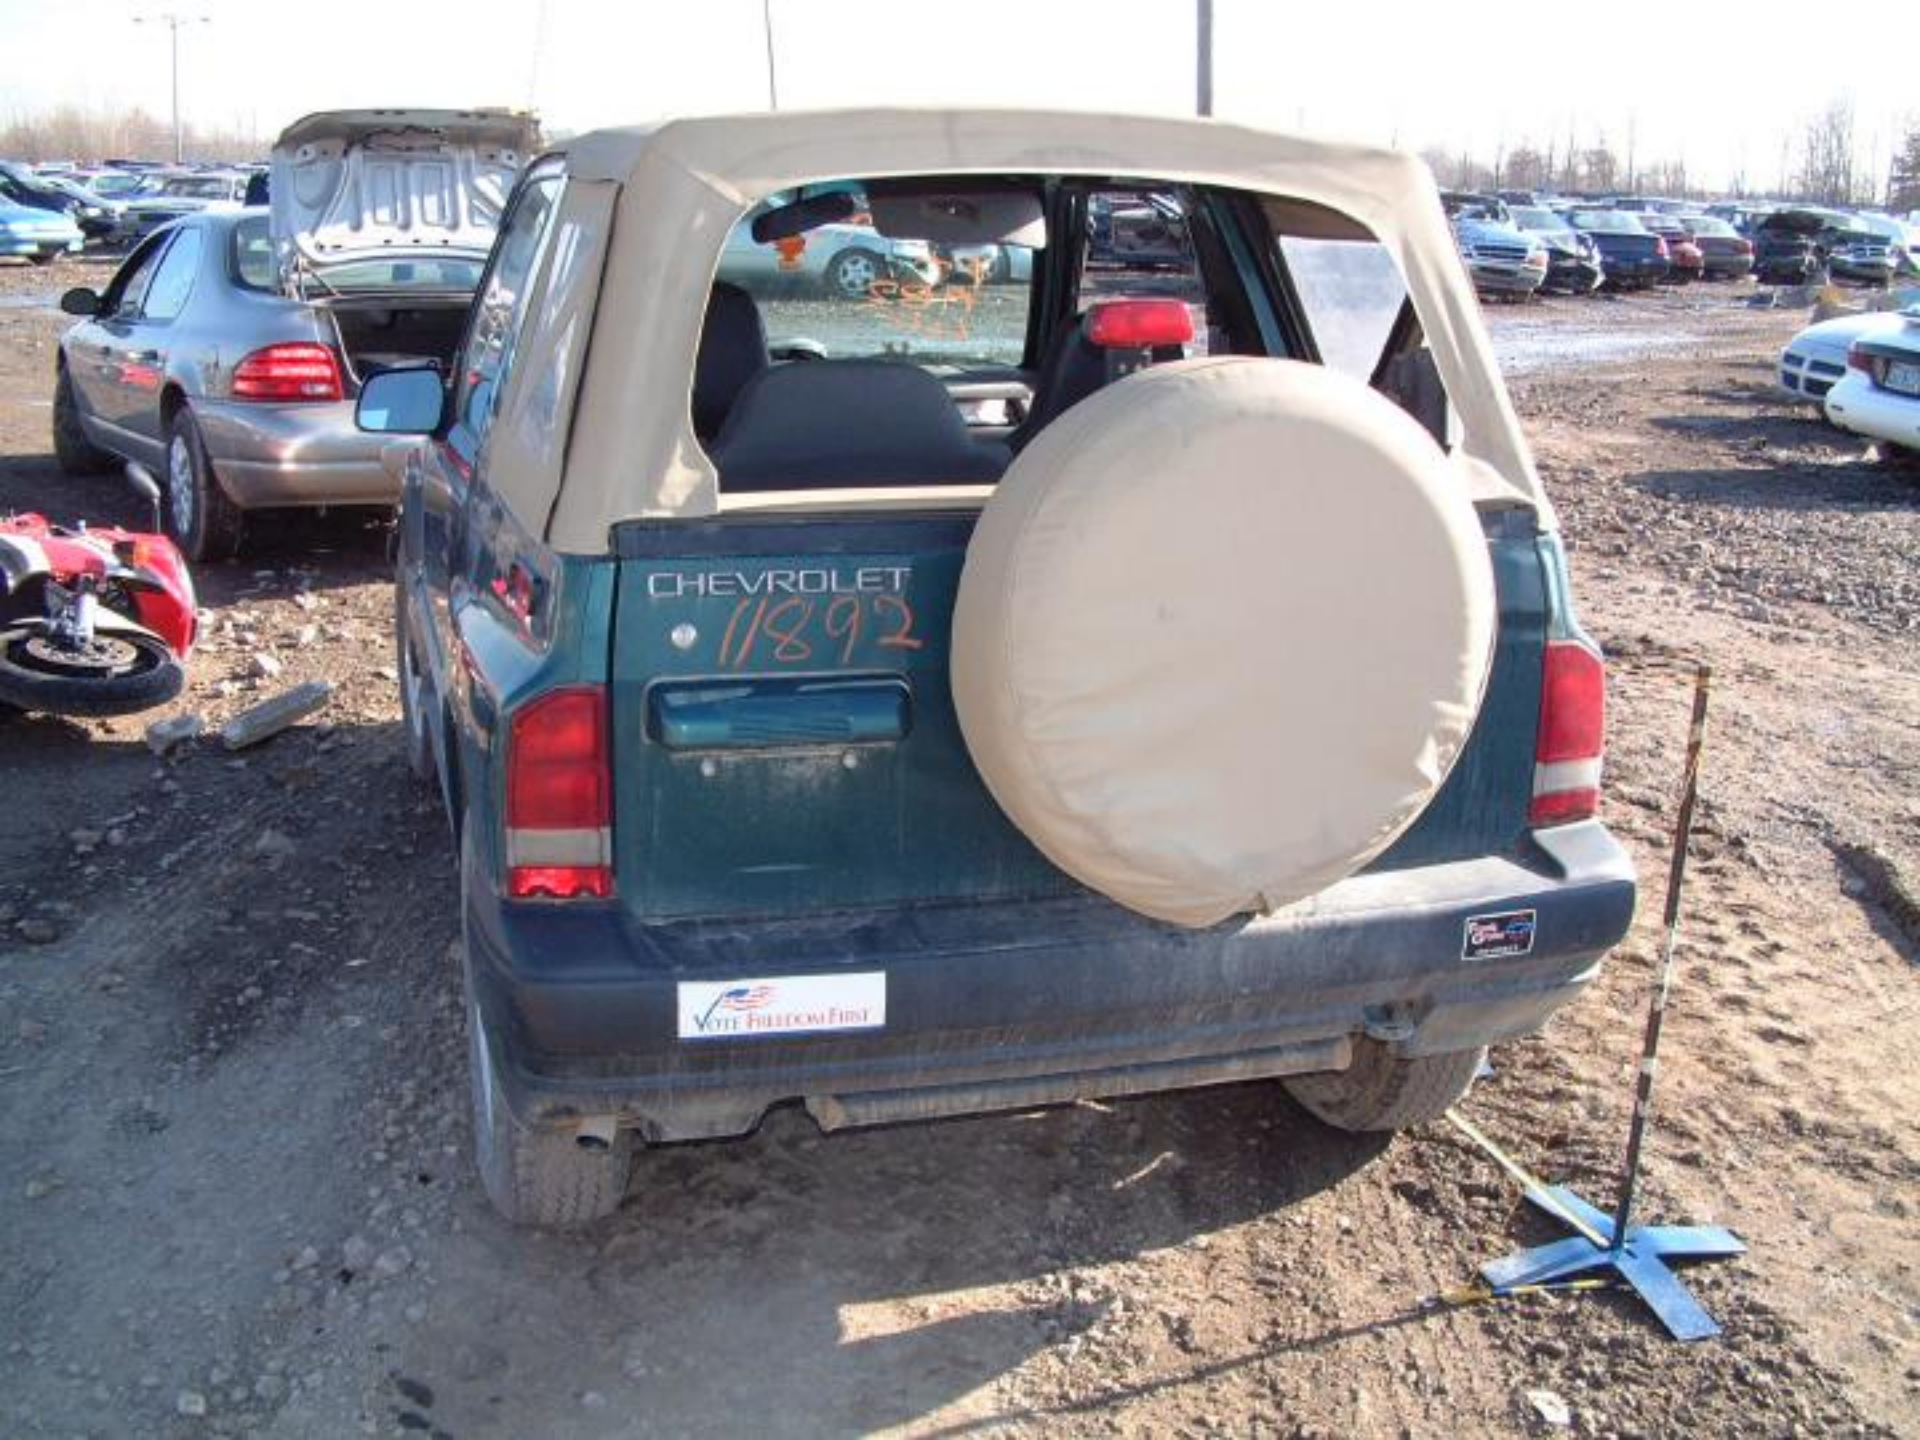
[7](#) On the right side, the front fender was crushed rearward and buckled. [26](#) The right-side door was closed and operational, and there was no right-side glazing damage. [27](#) The right wheelbase was reduced by 3 cm.

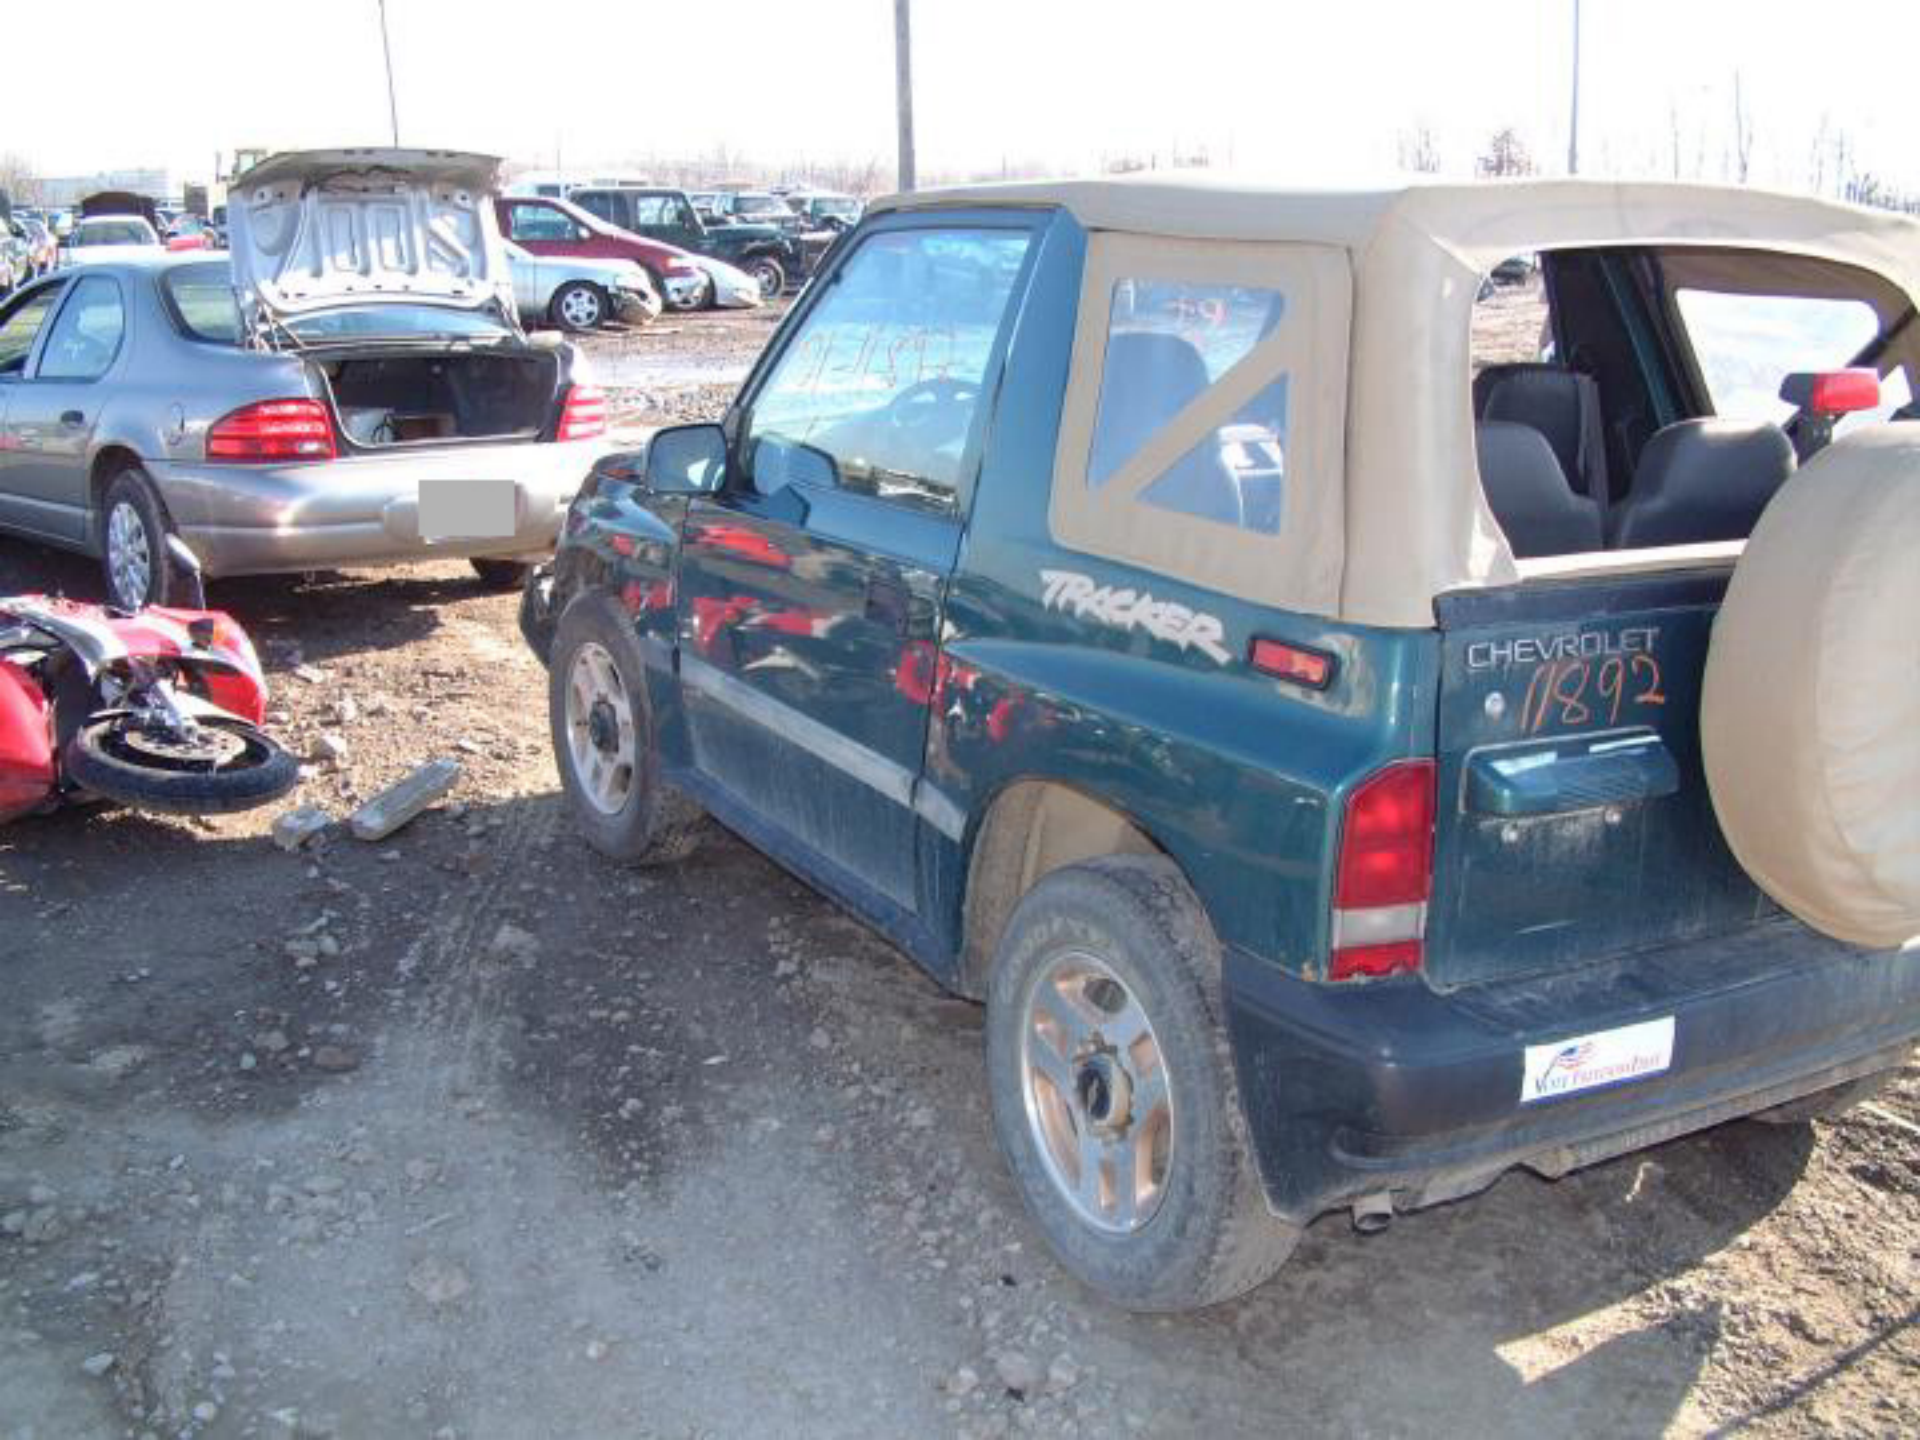
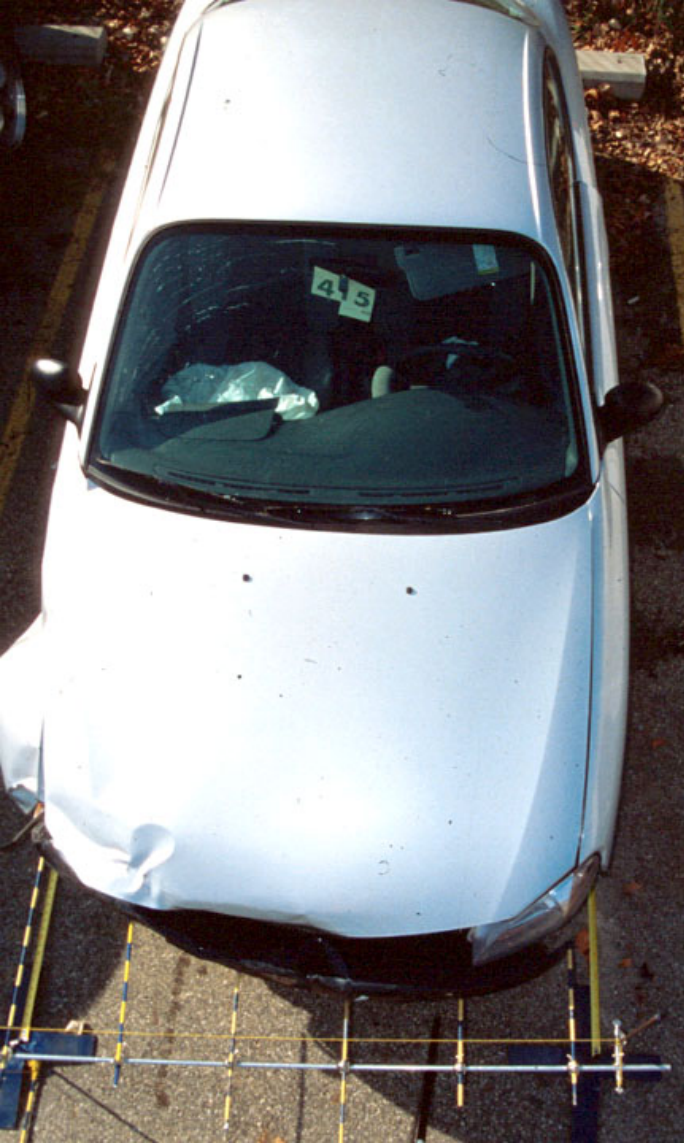
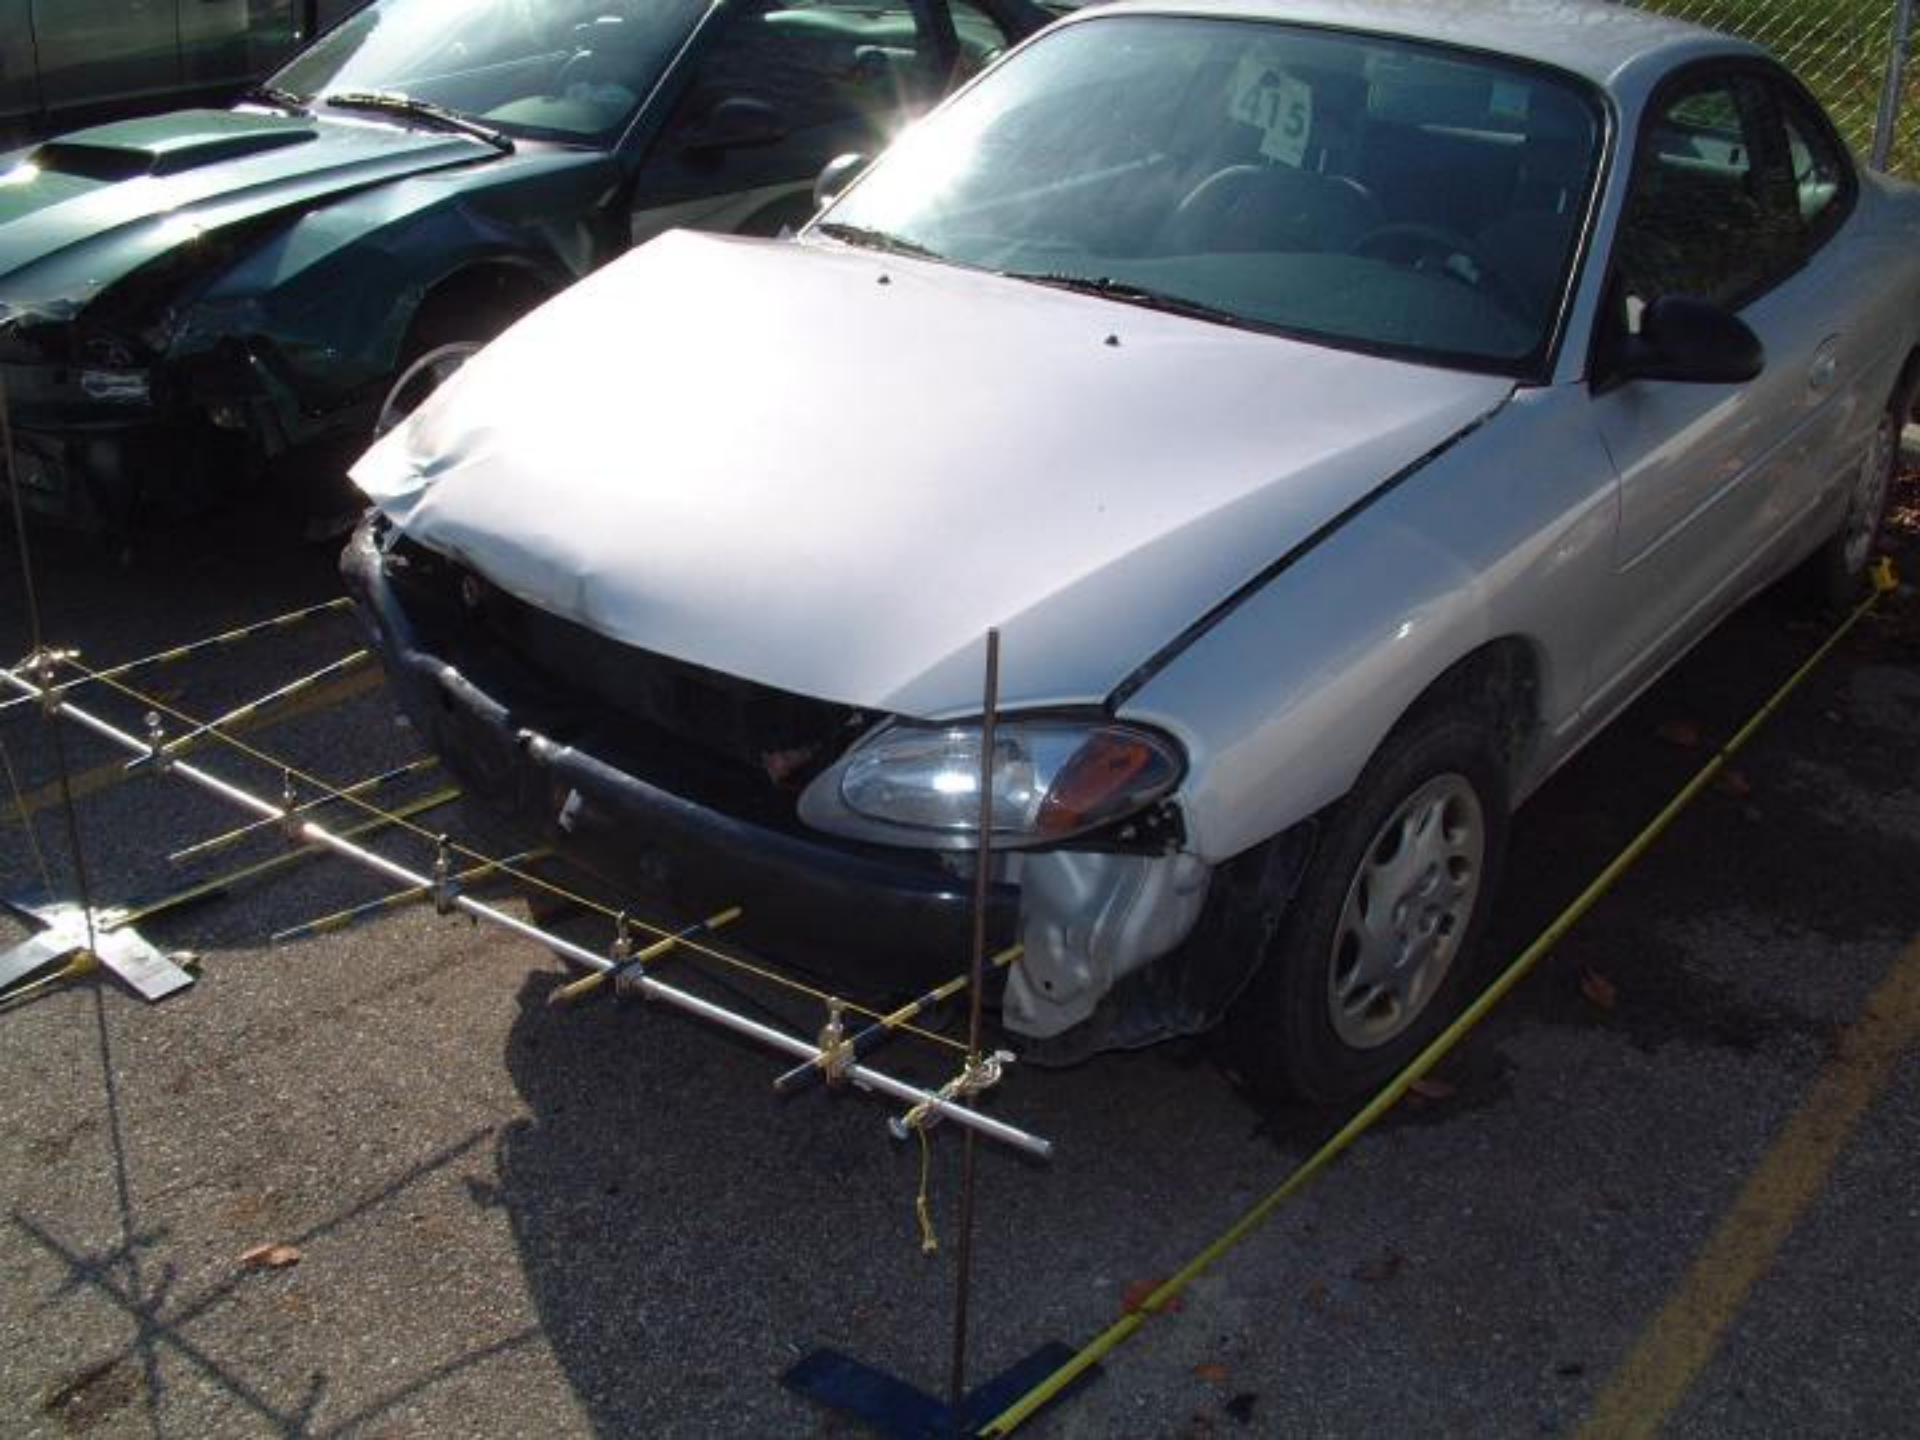
[28](#) [29](#) [30](#) There was no left-side damage, and no significant change in the left wheelbase. The left door remained closed during the crash and was operational.
